# PROFILE PUBLICATIONS

## The De Havilland D.H.5

**181**

# The De Havilland D.H.5

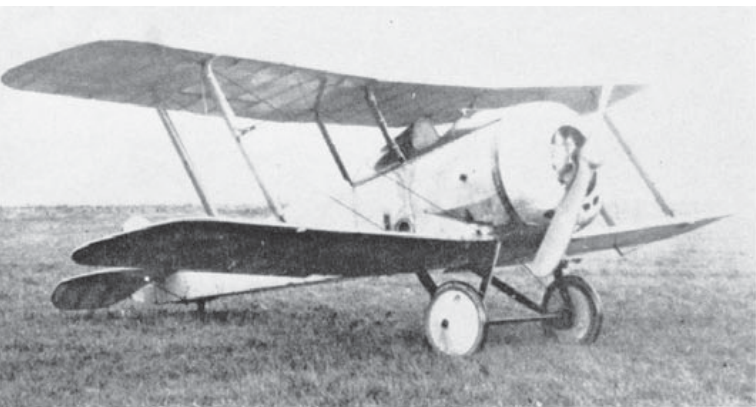
*The prototype, still unarmed and with its original fin and rudder, but with a small spinner on the airscrew hub.*

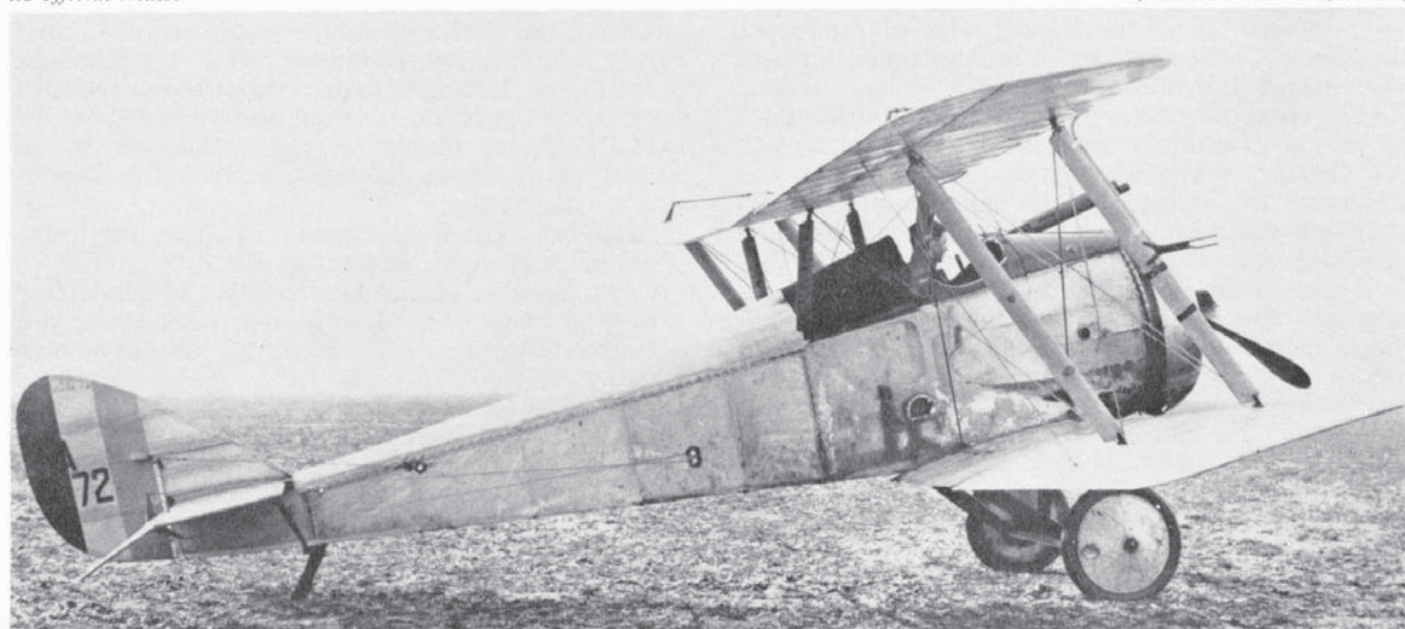
*The modified prototype with enlarged rudder, strut-braced tailplane, and Vickers gun on elevating mounting. The serial number A5172 was carried on the rudder. The photograph was most probably made at Central Flying School while the D.H.5 was undergoing its official trials.*

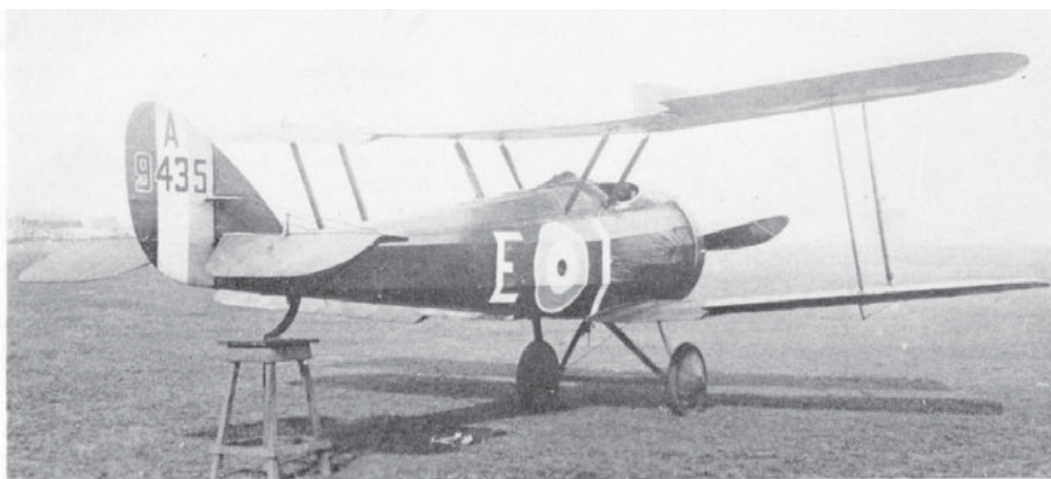
A9435 of No. 24 Squadron was captured intact by the Germans and is here seen at Adlershof. This aircraft had the stiffened engine cowling and full-span aileron balance cables in place of the earlier rubber-bungee return springs.

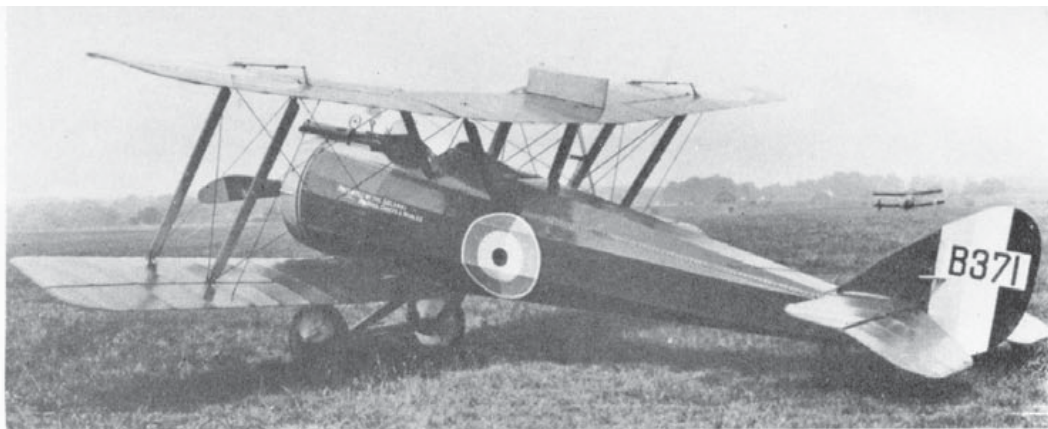
*The D.H.5s of the batch B331-B380 built by British Caudron were distinguished by the unusual style of lettering used in the presentation of their serial numbers. The characters had angular corners, much as in the standard letters and numerals used on American aircraft at the present time. The Caudron-built D.H.5s were probably unique among contemporary British aircraft in having lettering of this kind applied at the factory. This D.H.5 was a presentation aircraft and bears on its fuselage side the inscription "Presented by the Solanki Princes, Chiefs and Nobles."*

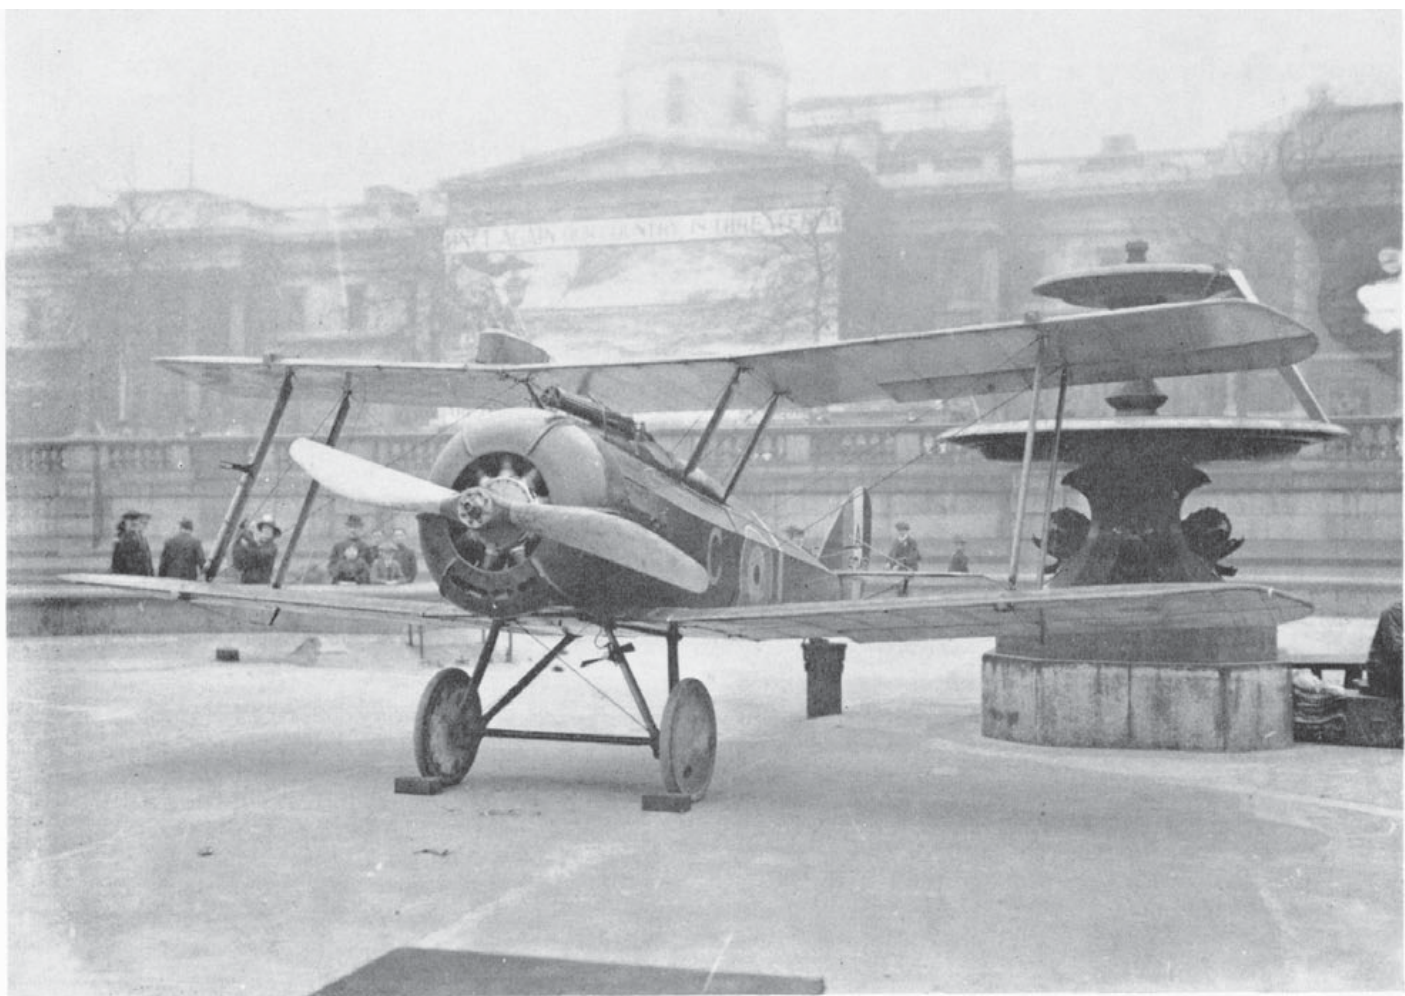
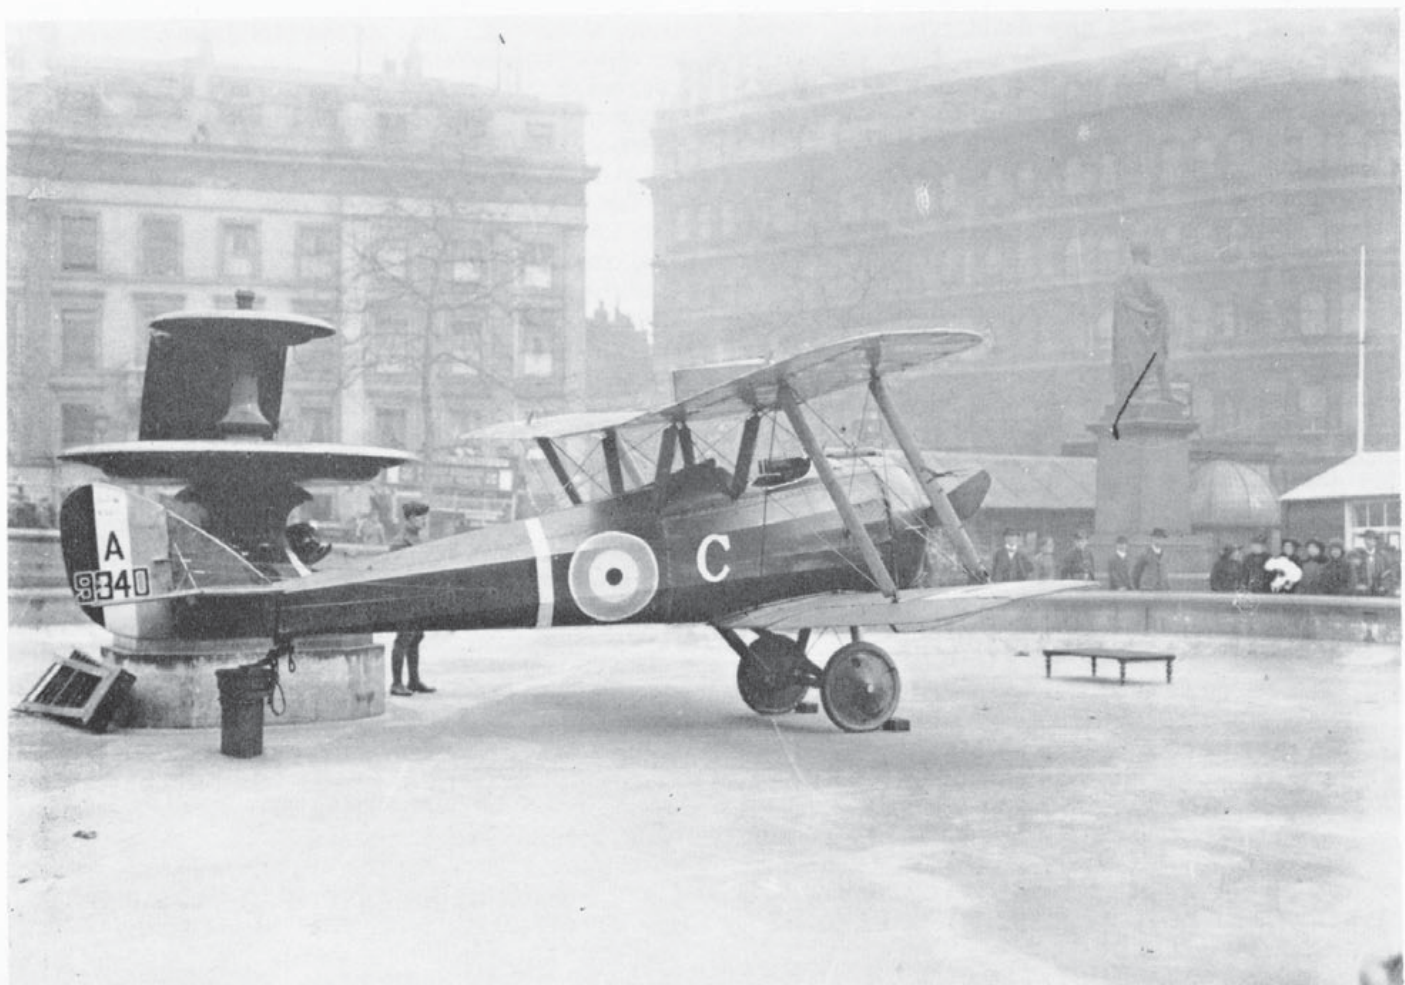
A9340 on display in Trafalgar Square in March 1918 during the Y.M.C.A. Blue Triangle Week. The aircraft seems to have been something of a lash-up for this occasion: the lower starboard wing has a roundel on its upper surface and must originally have been an upper wing on another D.H.5; and the underwing aileron control cables are slack. The markings are those of No. 32 Squadron, R.F.C., but the authenticity of the individual letter C is questionable. (Photos: Flight International 33 and 34)

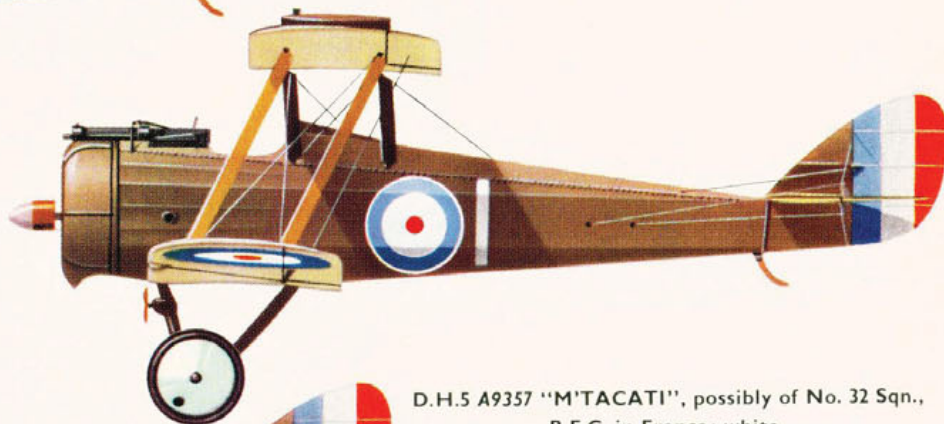
D.H.5 A9357 "M'TACATI", possibly of No. 32 Sqn., R.F.C. in France; white fuselage band broader than was usual.

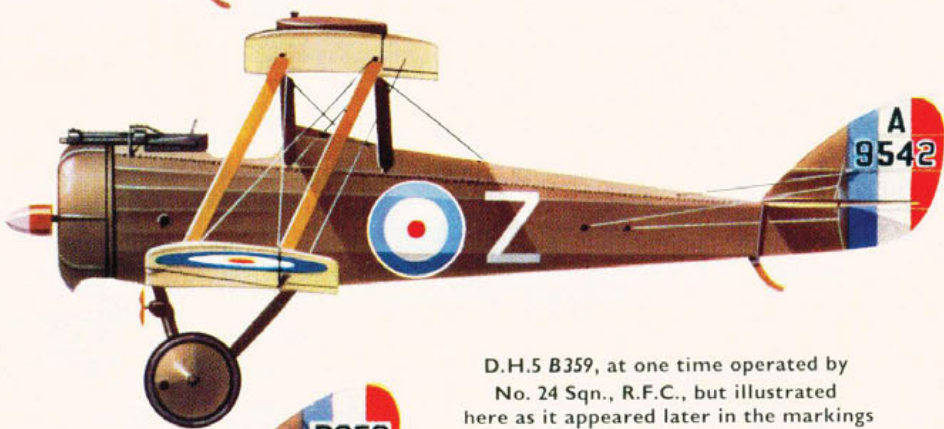
D.H.5 B359, at one time operated by No. 24 Sqn., R.F.C., but illustrated here as it appeared later in the markings of a training unit. Black 'B' on underside of starboard lower wing; also note angular characters in which serial is presented.
